201 & 205 N YAKIMA AVENUE

FEBRUARY 2020
HISTORIC PROPERTY ASSESSMENT REPORT

201-205 N YAKIMA STREET

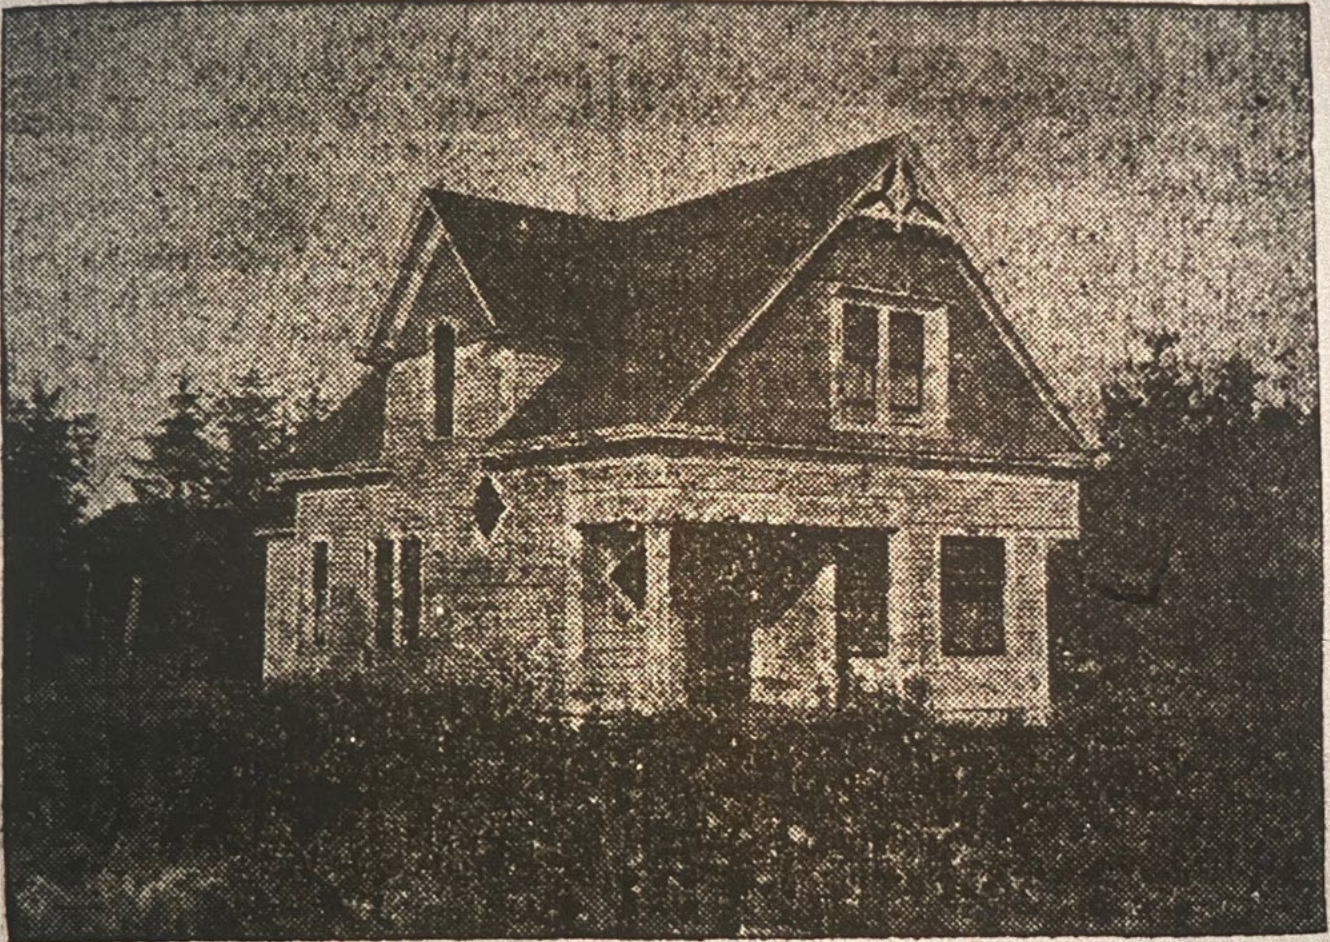
Figure 1 • "Harry Nash's New Home, 205 North Yakima Avenue," 1902

Harry Nash's New Home, 205 North Yakima Avenue.

This one-and-a-half-story residence contains seven rooms, pantry, bathroom and hall. The cost to build was \$2,100. The house stands on two lots and the ground dimensions of the house are 26x34 feet.

Harry Nash was the first owner and tenant of the residence at 205 N Yakima. He commissioned the house to be built by contractor J. E. Darling. Darling first appeared in Tacoma's historic record in 1900, when he was listed as a carpenter in the city directory. The next year he was listed in the directory as a building contractor, however, by 1904 Darling was listed as a real estate agent in the Provident Building. In 1907 he was working in real estate insurance and loans.³ *See figure 1.*

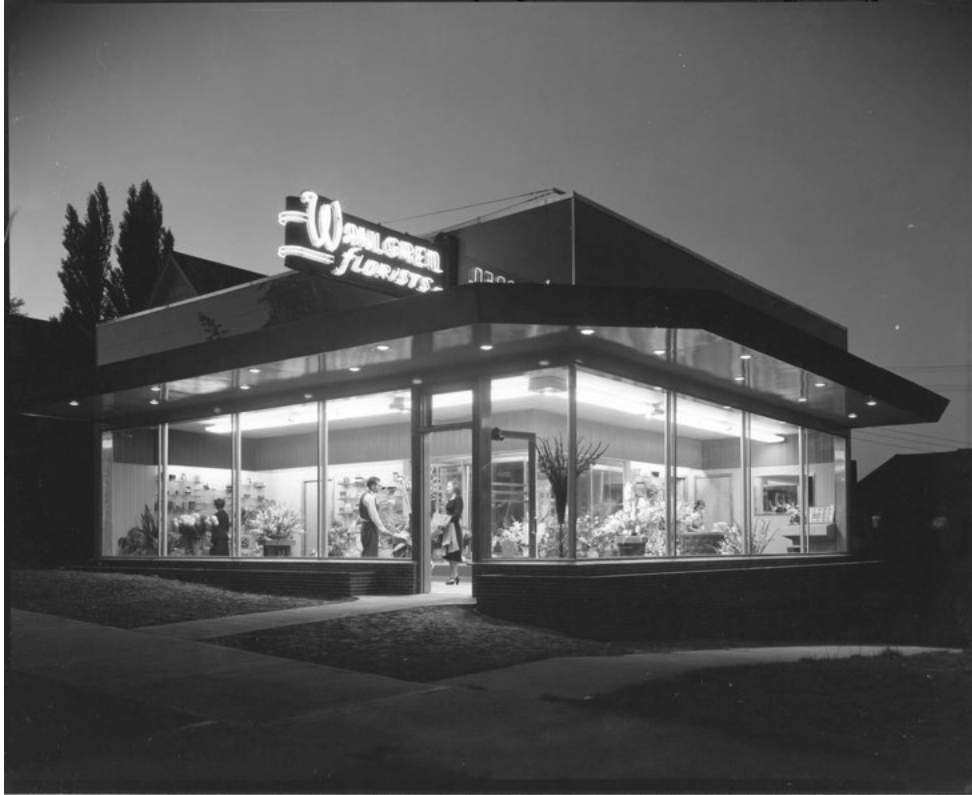
Figure 2 • Exterior of Wahlgren's Floral, 1949

Both the Yakima and Second street sides of the building are entirely of plate glass, capped with a marquee and blue vitrolite glass above. The foundation and window boxes are of attractive Roman brick.¹⁸ ***See figures 2-4***

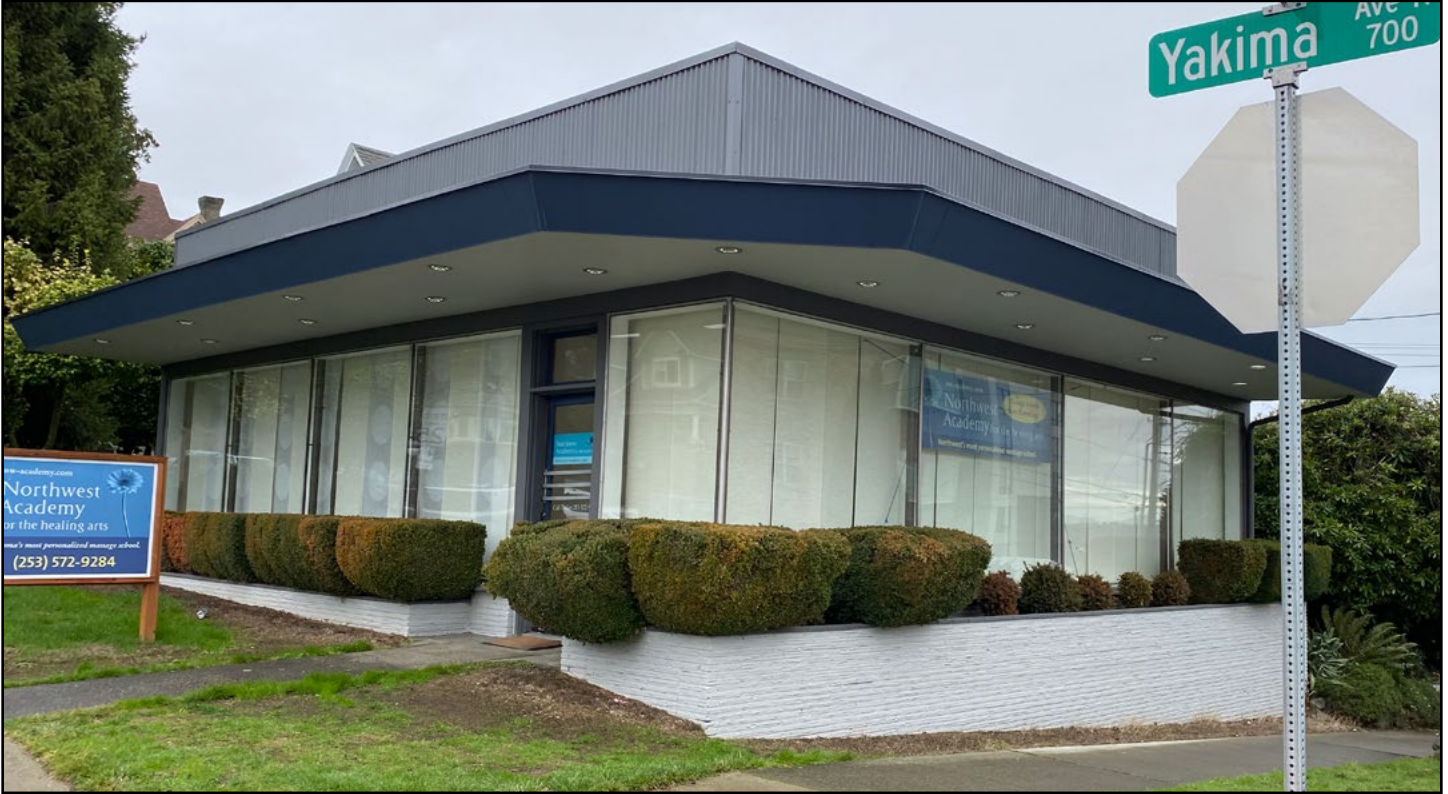
Figure 14 • 201 S Yakima, viewing from the south

The former floral shop building is a wood-framed, single-story structure with a flat roof and a metal-capped parapet. The foundation is poured concrete.

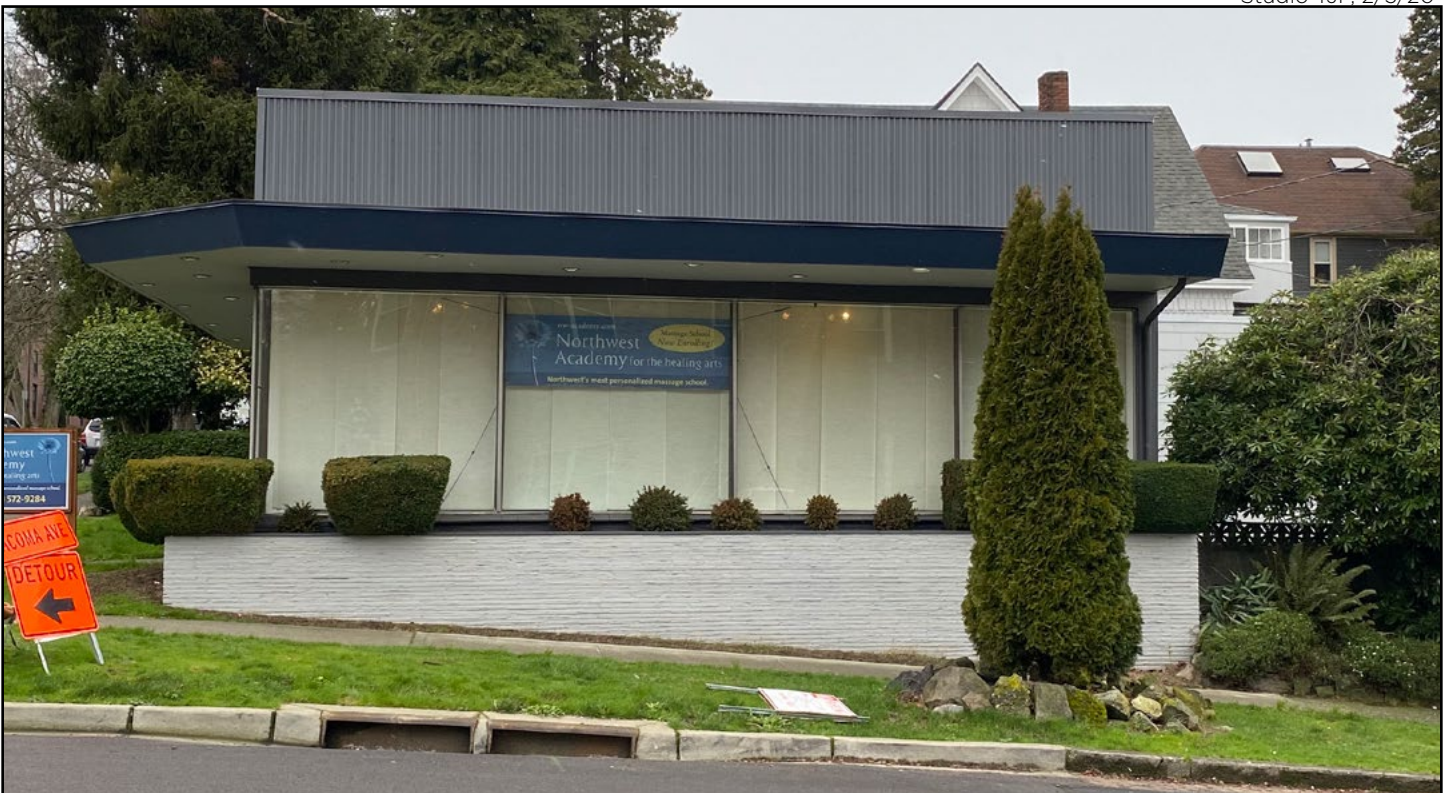
Figure 15 • 201 S Yakima, eastern façade

The eastern façade roof has a metal-capped parapet below which are non-original painted corrugated metal panels. On the eastern side of this façade, a wide marquee awning extends 6'-0" from the building and contains original, recessed metal lighting fixtures in a painted metal soffit. Below the awning is a built-in window wall that wraps the building and continues on the eastern façade. The original plate glass windows are aluminum frame, and behind each mullion is a four-inch steel column. At the base of the subject building, below the windows, is a built-in planter constructed of painted Roman bricks and capped with terra cotta tiles. On the western side of this façade, the building is clad in painted asbestos shingles. Located on this side is a small, single-light wood-frame window, a larger, square two-light sliding wood frame window, and a painted, flat-panel door with wooden trim. Cast-in-place concrete stairs lead from the driveway to this entryway.

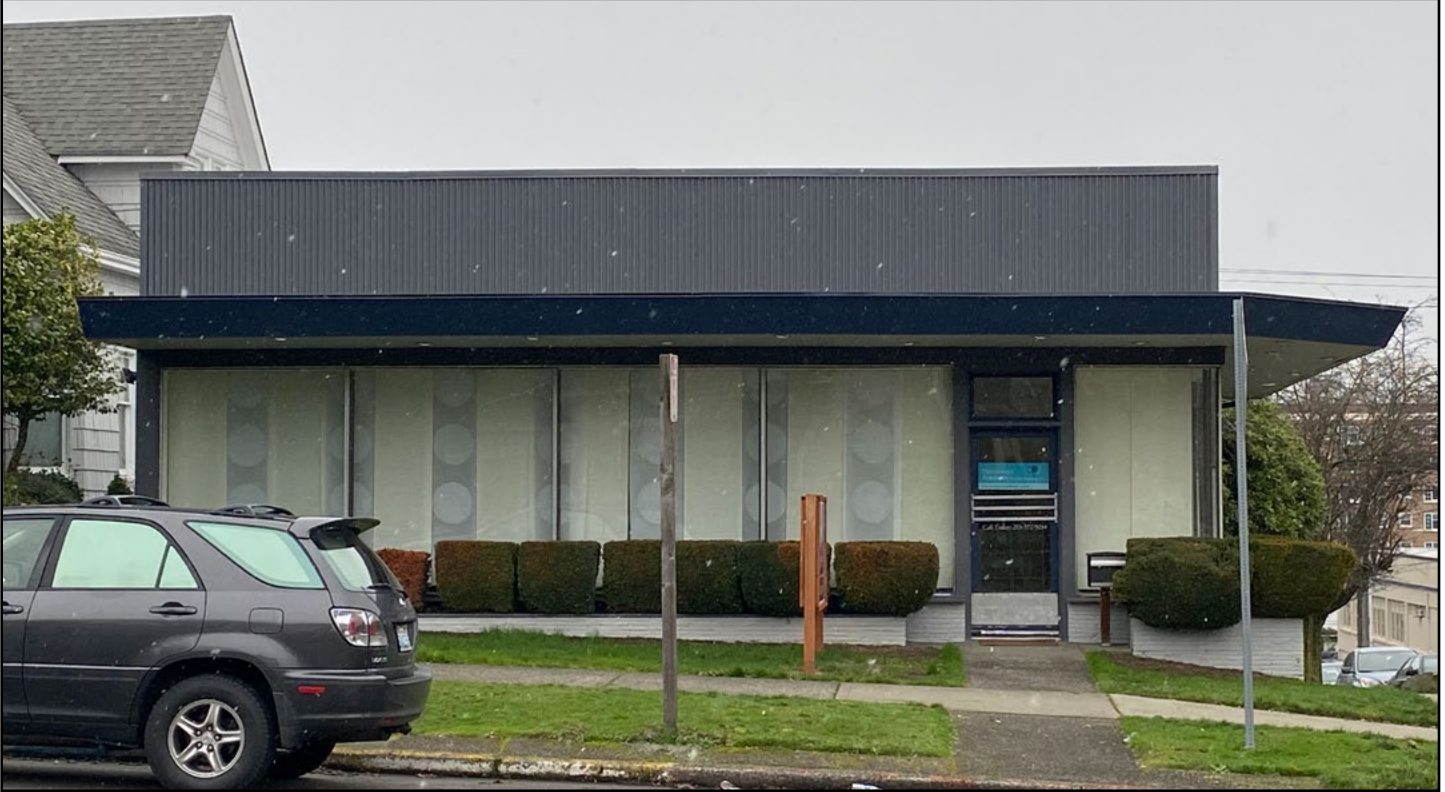
Figure 16 • 201 S Yakima, southern façade

The southern façade is similar to the eastern façade. A concrete walkway on the northern end of this façade leads from North Yakima Avenue to the main entry. The main entry is a glass commercial door with a single-light transom above.

The subject building is in fair physical condition. There is some minor damage to the terra cotta tiles lining the windows sills located on the southern and western façades. The property appears well maintained.

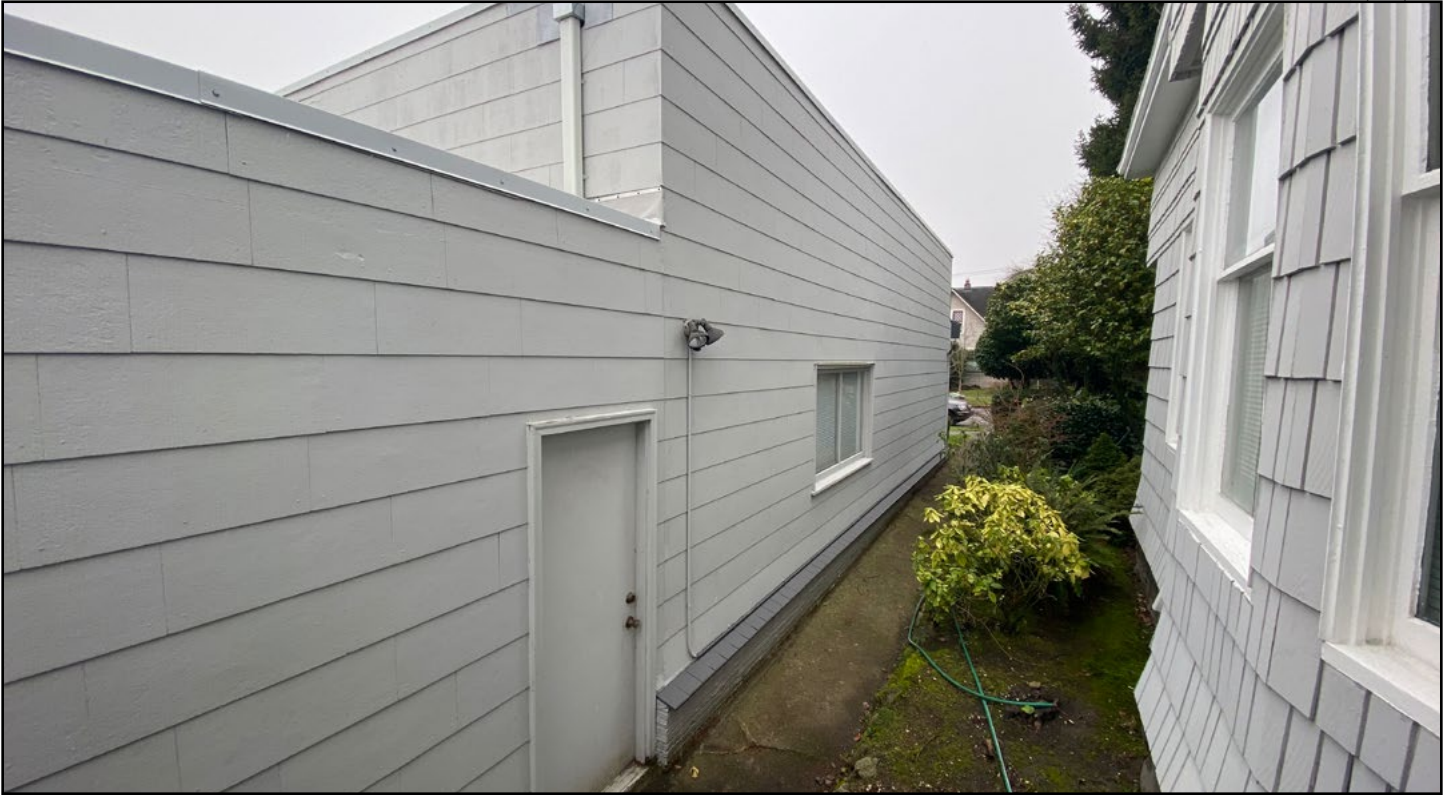
Figure 18 • 201 S Yakima, western façade

The western façade has a metal-capped parapet at the roof. The entire façade is clad in non-original, painted asbestos shingles. The façade contains a single rectangular two-light sliding window with a wood frame and a single painted flat-panel door with wooden trim. At the base of the original building, the Roman brick topped with terra cotta tiles continues from the eastern façade. At the far west of the façade, the building abuts an enclosed storage area which also serves as a porch to the adjacent residential building.

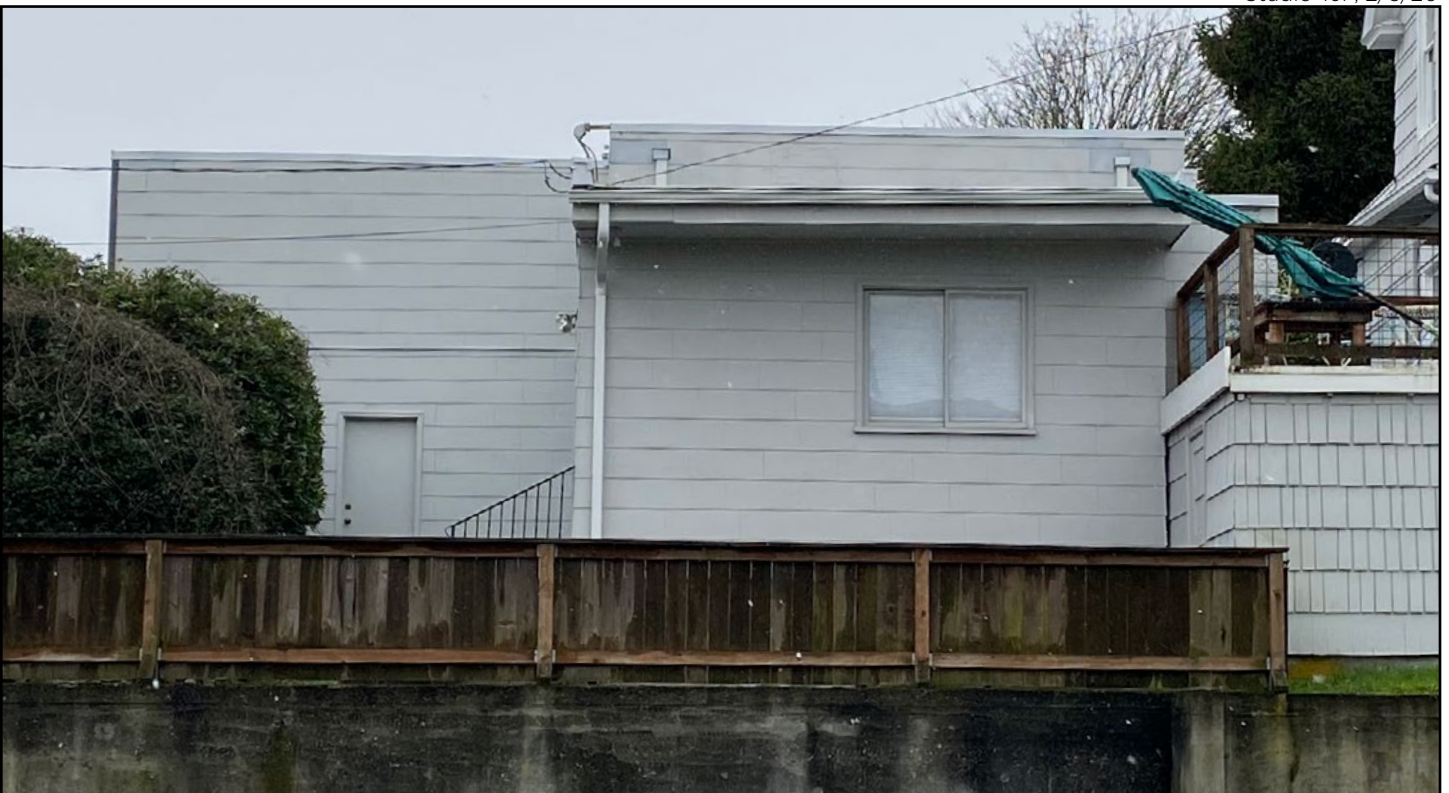
Figure 19 • 201 S Yakima, northern façade

The northern façade is similar to the western façade. A portion of the building protrudes to the west, with a three-foot awning and a painted metal soffit. The flat roof of this portion of the building is approximately five feet lower than the roof of the original building. There is a square two-light sliding wood frame window on the protruding wall, and a flat panel door with cast-in-place concrete stairs located on a wall set further back. **See figures 14-20.**

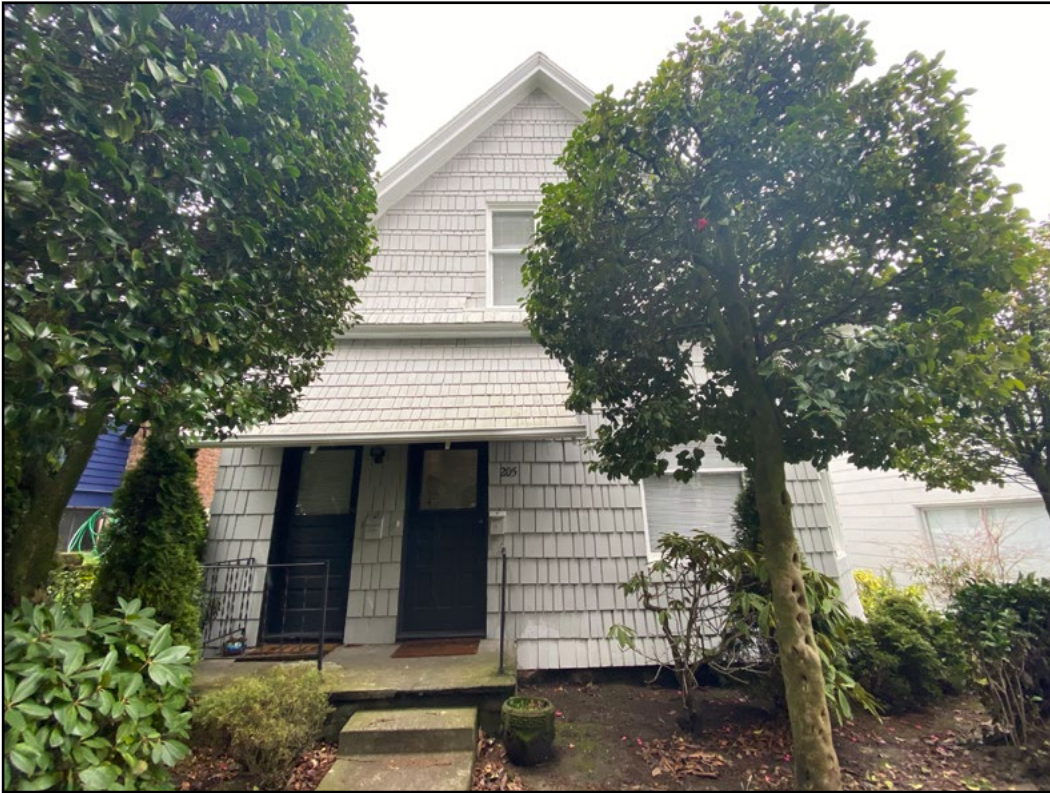
Figure 24 • 205 S Yakima, southern façade

The southern façade faces North Yakima Avenue. The cross-gable roof has a one-foot overhang with original painted wood trim. At the roofline is a decorative cornice return on either side. Set between the returns is a somewhat recessed portion of wood trim spanning the length of the façade, causing a minor flair of the siding at the upper floor. A pent roof supported by curved wooden brackets covers the doors leading to Units A and B and has painted wooden shingles similar to the siding on the main floor. There are two double-hung, wooden-frame windows on the upper floor and a double-hung, wooden-frame window on the main floor. At the corner of the building, between the eastern and southern façades, is another wooden-frame, double-hung window set in an angled portion of wall. Originally this façade contained an open porch on the western side of the main floor. The porch was probably filled in when the residence was converted to a duplex sometime before the 1930s. The duplex conversion may have led to other alterations, such as shortening the window at the upper floor in the gable end, and accounting for the awkward pent roof intersections.

The subject building is in fair physical condition. There is some minor water damage to the wooden shingles in certain locations.

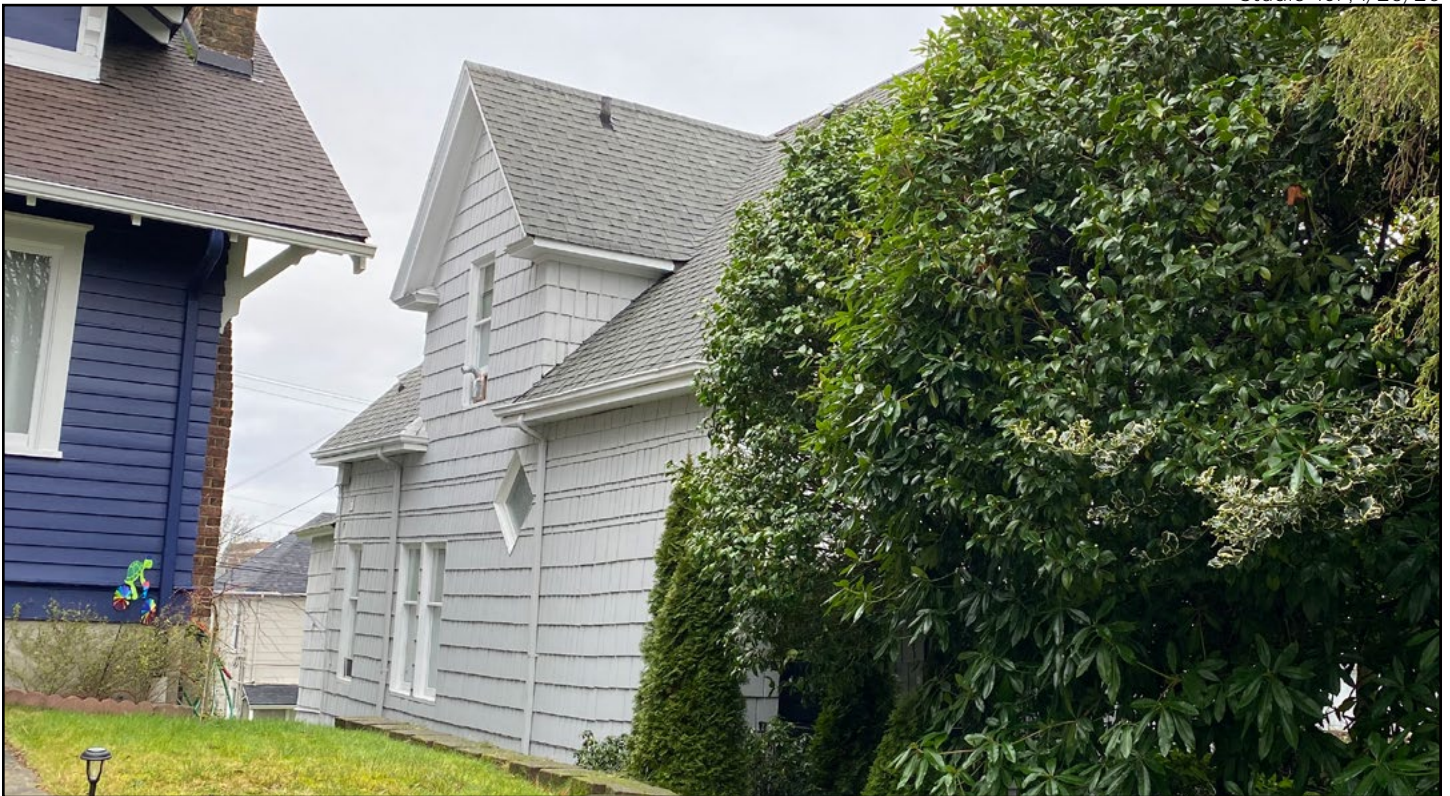
Figure 25 • 205 S Yakima, western façade

The western façade has a single dormer with cornice returns. The western wall of the dormer is flush with the western façade. There are seven wood-frame windows on this façade. One double-hung window is set into the dormer on the upper floor. Between the two levels, where the interior stairway turns, is a fixed, diamond-shaped window. Located near the northern end of the main floor are three additional double-hung windows. At the far northern end of this façade, a portion of the lower- and upper-level enclosed porch areas are visible. The upper porch is clad in painted wood and has two six-light sliding windows. The lower porch is clad in a manner similar to most of the western façade.

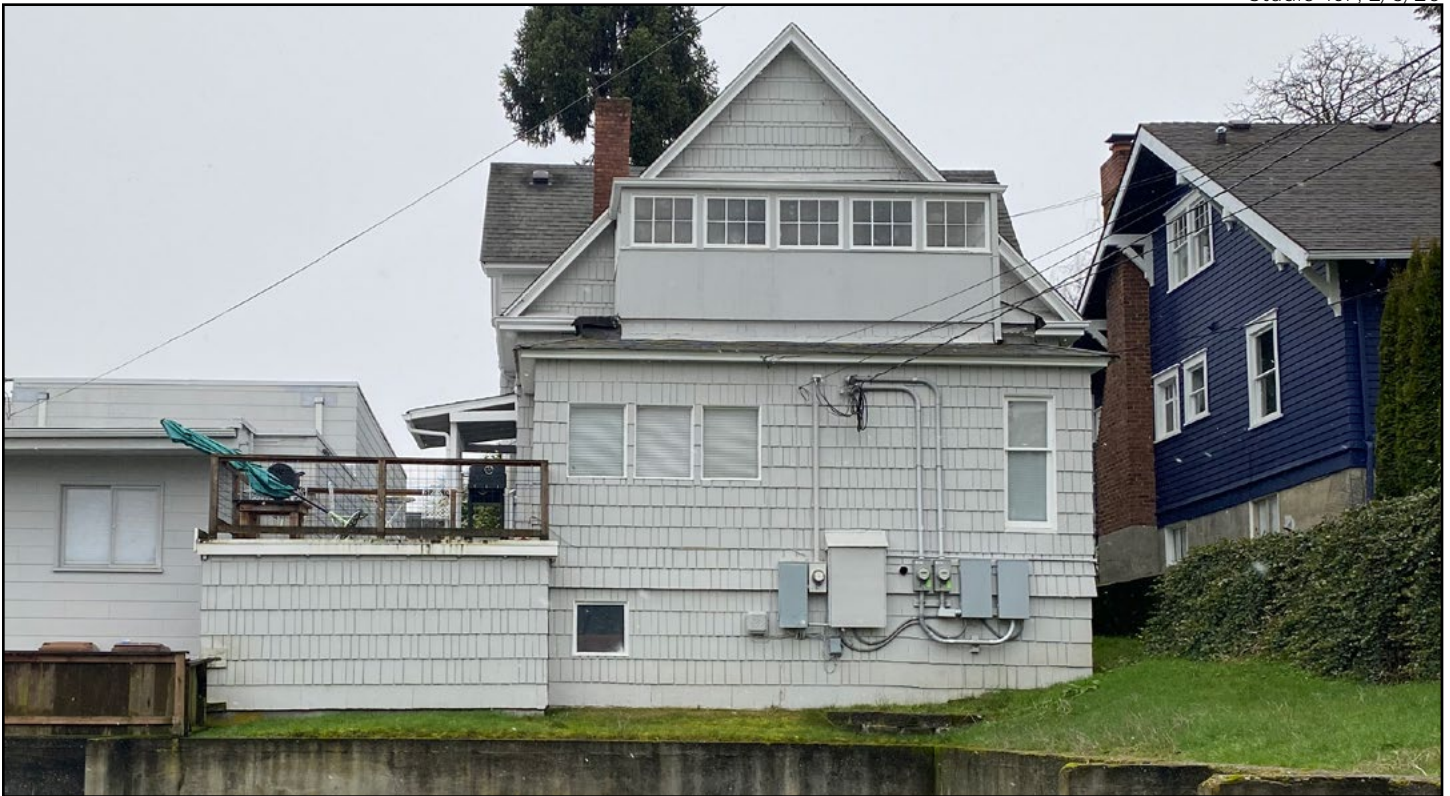
Figure 26 • 205 S Yakima, northern façade

The northern façade has two dormers, visible on either side of the roof. Centered on the roof is the enclosed porch addition with an asphalt-shingled hip roof. At the main floor, the enclosed porch, also clad in wooden shingles, has a composite asphalt shingle roof. The basement level is also clad in shingles and no area of the foundation is exposed. A portion of the storage shed

façade is visible. The siding on the storage shed is consistent with that of the main floor of the house, and the flat roof is used as a patio with a wood and wire railing. There are four rectangular six-light wooden-frame windows at the upper level; three fixed single-light wooden-frame windows and one rectangular wooden-frame, double-hung window at the main floor; and a fixed single-light wood-frame window at the basement level.

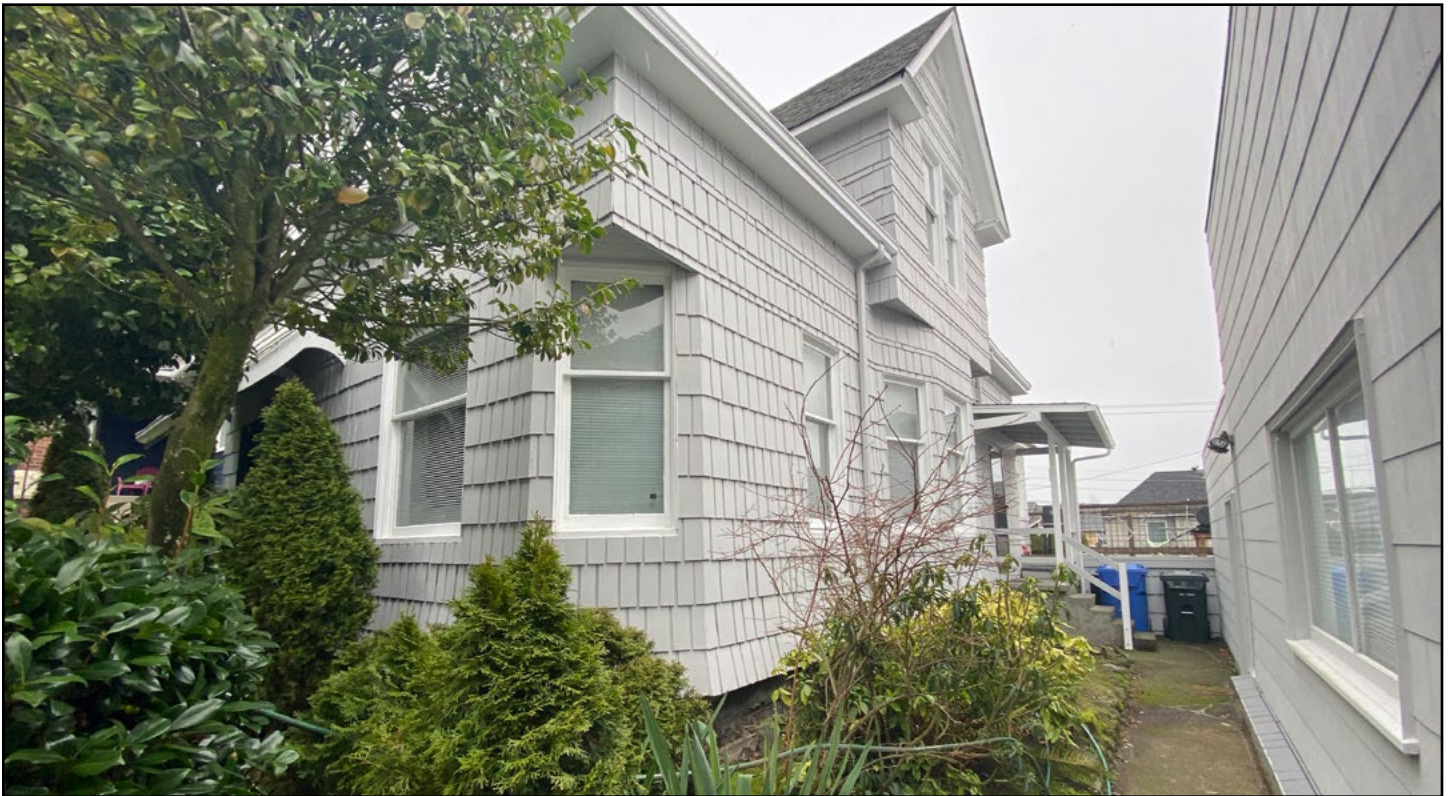
Figure 28 • 205 S Yakima, eastern façade

The eastern façade contains a single dormer. The eastern wall of the dormer is not flush with the façade, overhanging at the corners. This is due to a bay window located just below at the main level. A set of cast-in-place stairs at the northern end of the façade leads from the basement entry. A second stair leads up to the main floor kitchen or to the porch located above the storage shed. At the basement level the foundation is exposed rusticated granite masonry. The eastern façade of the storage shed is similar to the shed's northern façade, and contains a single five-panel painted door accessing the interior. *See figures 24-28.*
