Thea Foss Waterway Project

City of Tacoma | Environmental Services Department

Government Performance & Finance Committee

April 4, 2023

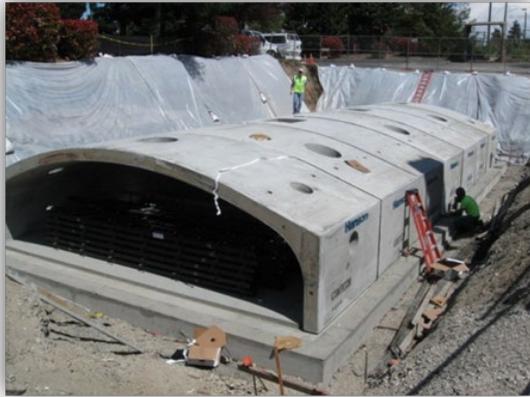
Ferry ST – 61 Acres

Stormwater Treatment

Stormwater Treatment Facilities in Foss Watershed

- 3 Regional
- 55 Public
- 219 Private

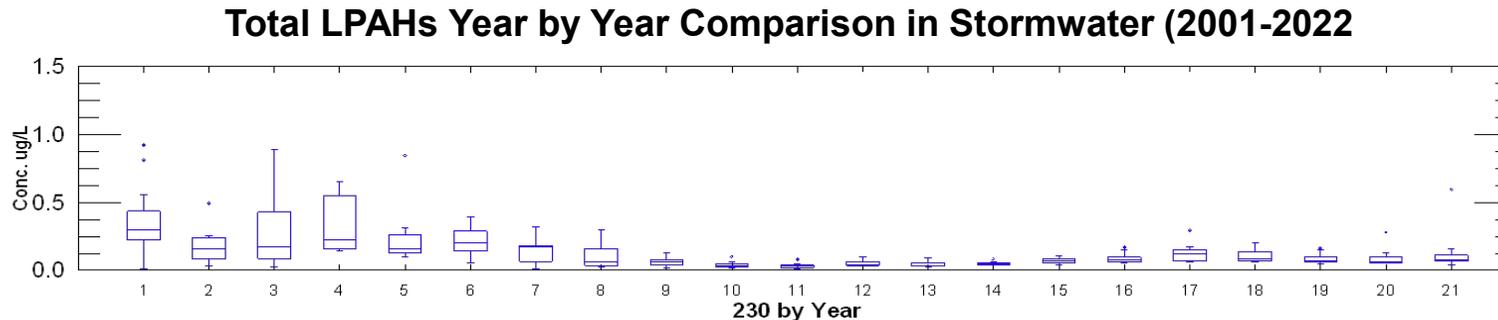
Example – Total LPAH concentrations have decreased to low levels and further decrease may not be feasible.

- Of the 49 tests performed 48 had decreasing trends over the 21 year monitoring period completed to date

OUTFALL	CHEMICAL	PERCENT REDUCTION
In 5 Outfalls	Solids	40-78%
All 7 Outfalls	Lead	71-83%
All 7 Outfalls	Zinc	51-71%
All 7 Outfalls	PAHs	64-90%
All 7 Outfalls	DEHP	48-82%

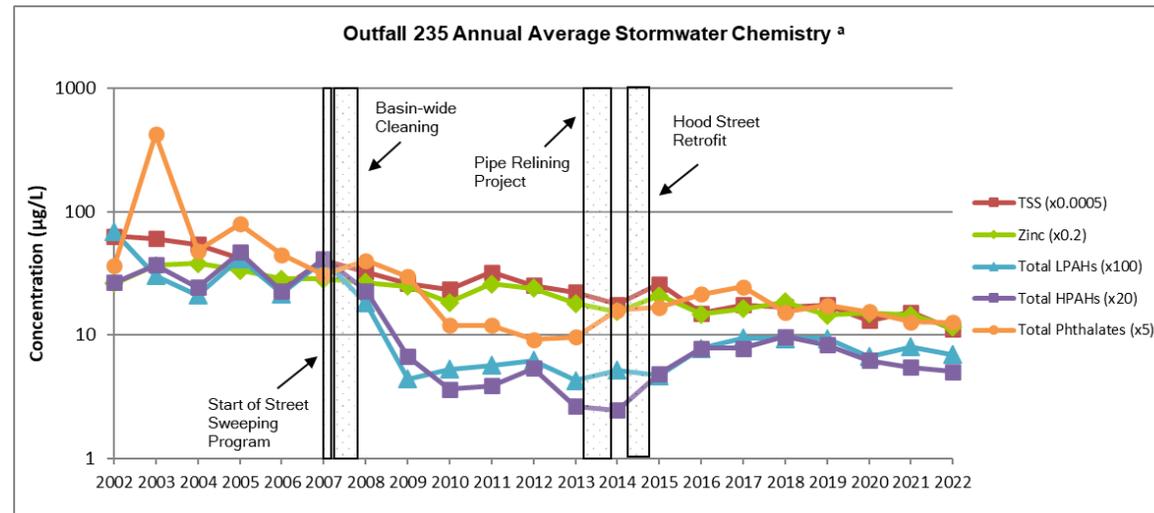
Average Annual Stormwater concentrations overtime with major source control activities
