Occidental Chemical Tacoma Project

Toxics Cleanup in Commencement Bay

Occidental Chemical Corporation, Tacoma, Washington

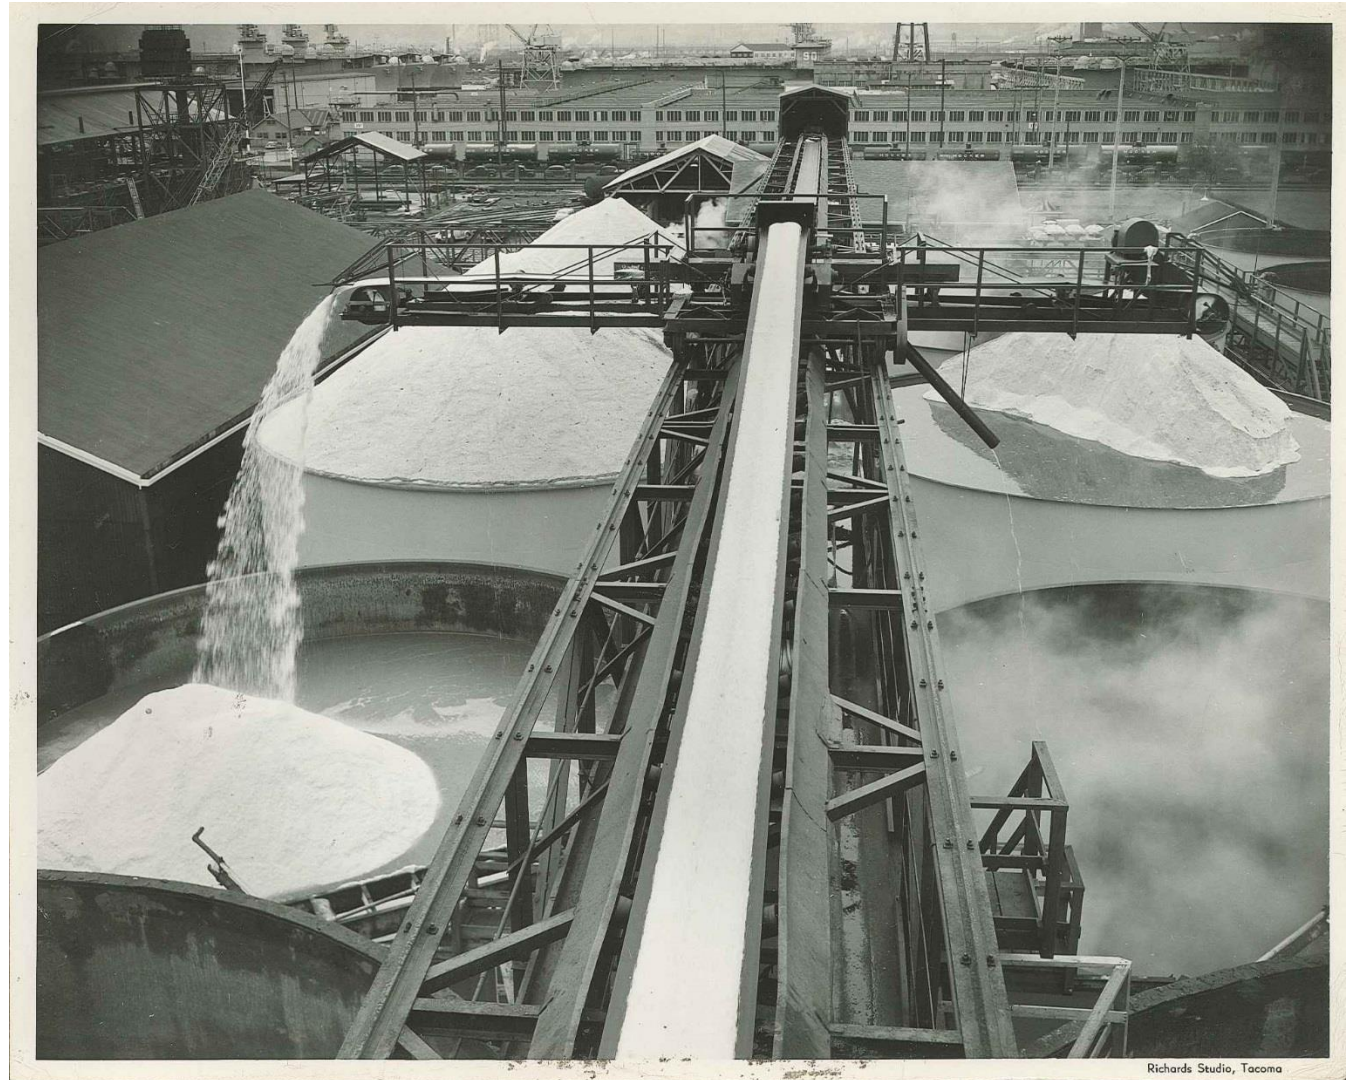
Chlorine and Caustic Soda (1929–2002)

- Salt Pad (early 1960s–2002)
- Cell Houses
- Caustic Storage
- Elevated pH and elevated density

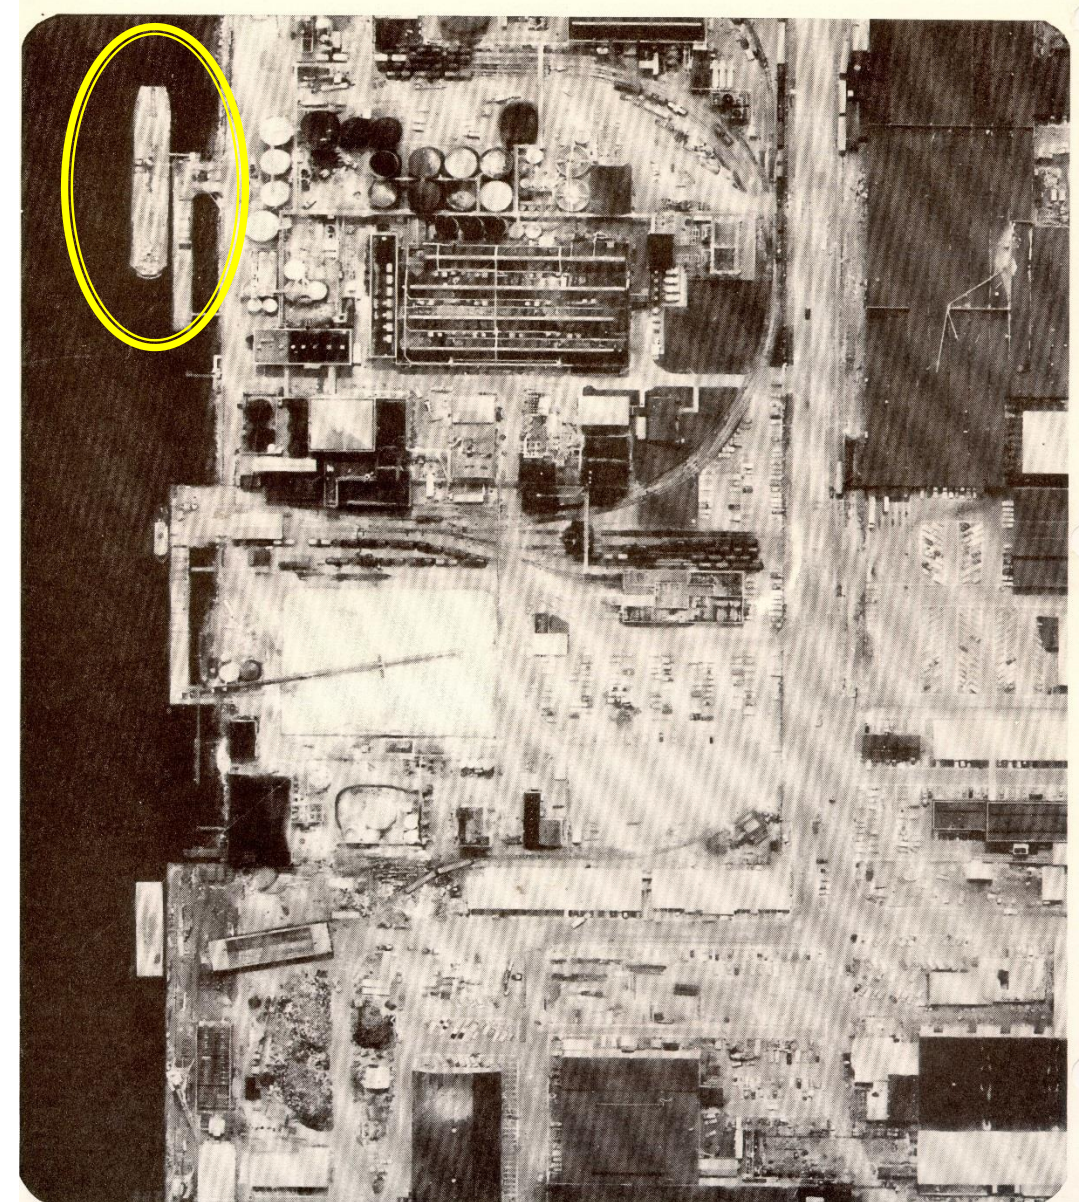
PCE / TCE Process (1947–1973)

- Process Plant
- Lime Sludge Settling Ponds
- Lime Sludge Barge
- Effluent to Hylebos (Area 5106)
- Impacted groundwater, sediments and saturated and unsaturated soils
- Primary VOCs
- Groundwater plume extends under Hylebos Waterway

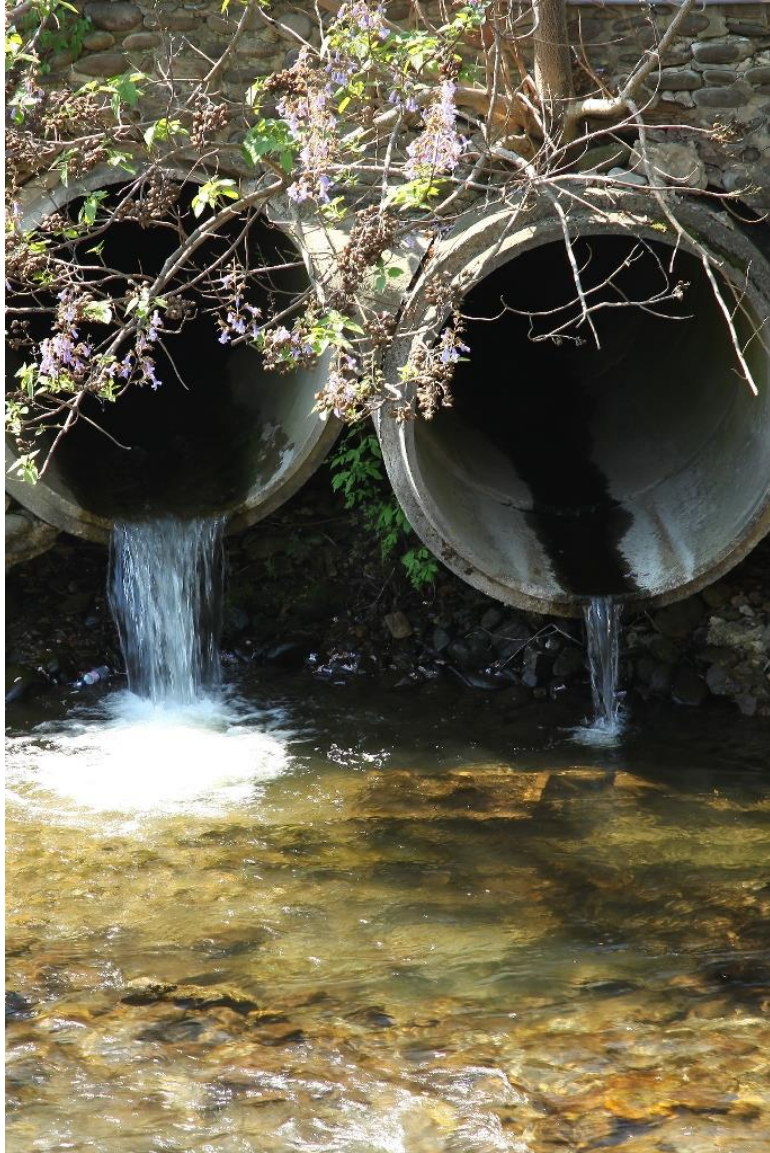
Solvent Loss Estimates

- ▶ 457 million pounds of solvent were produced.
- ▶ 1 million pounds lost to subsurface.

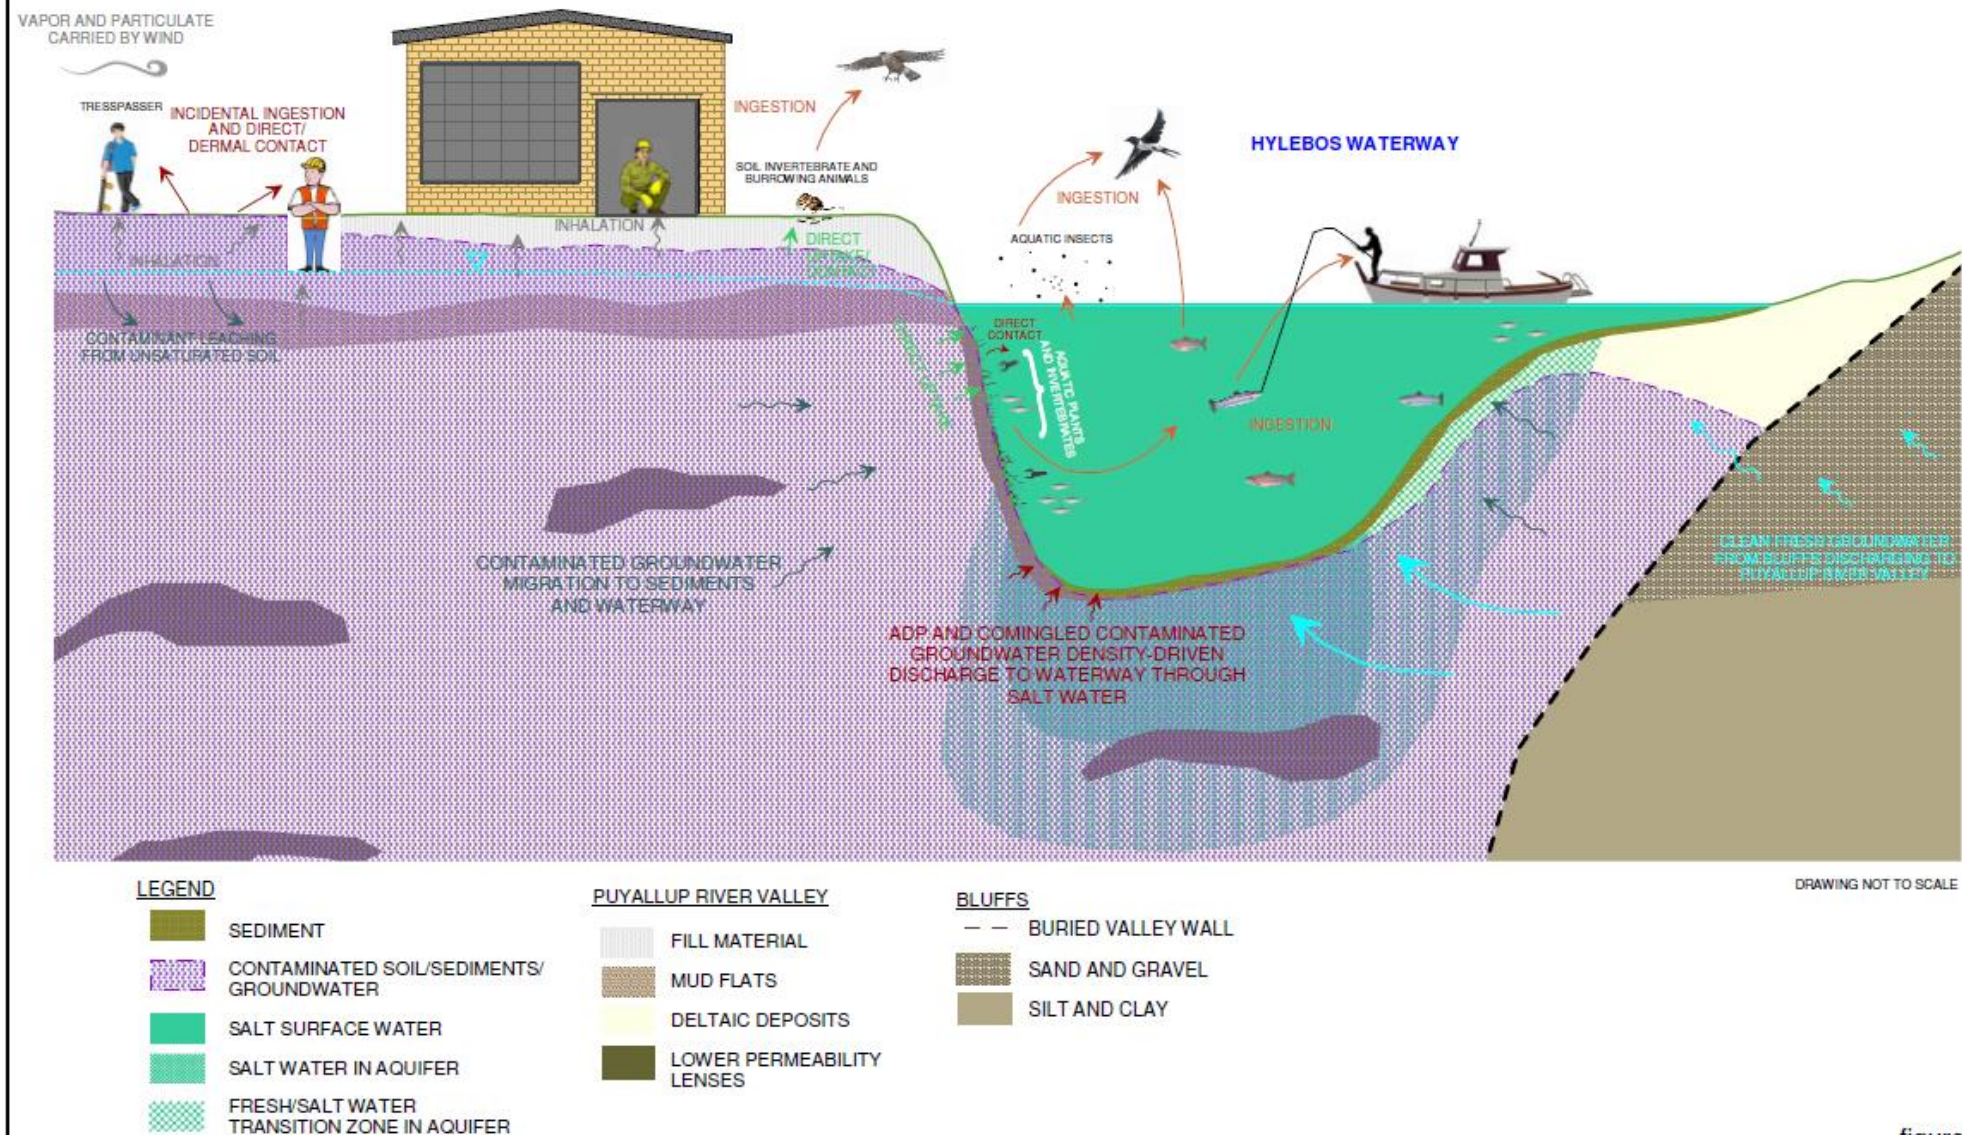
figure 6.1

SCHEMATIC OF EXPOSURE PATHWAYS AND RECEPTORS
Occidental Chemical Corporation, Tacoma, Washington

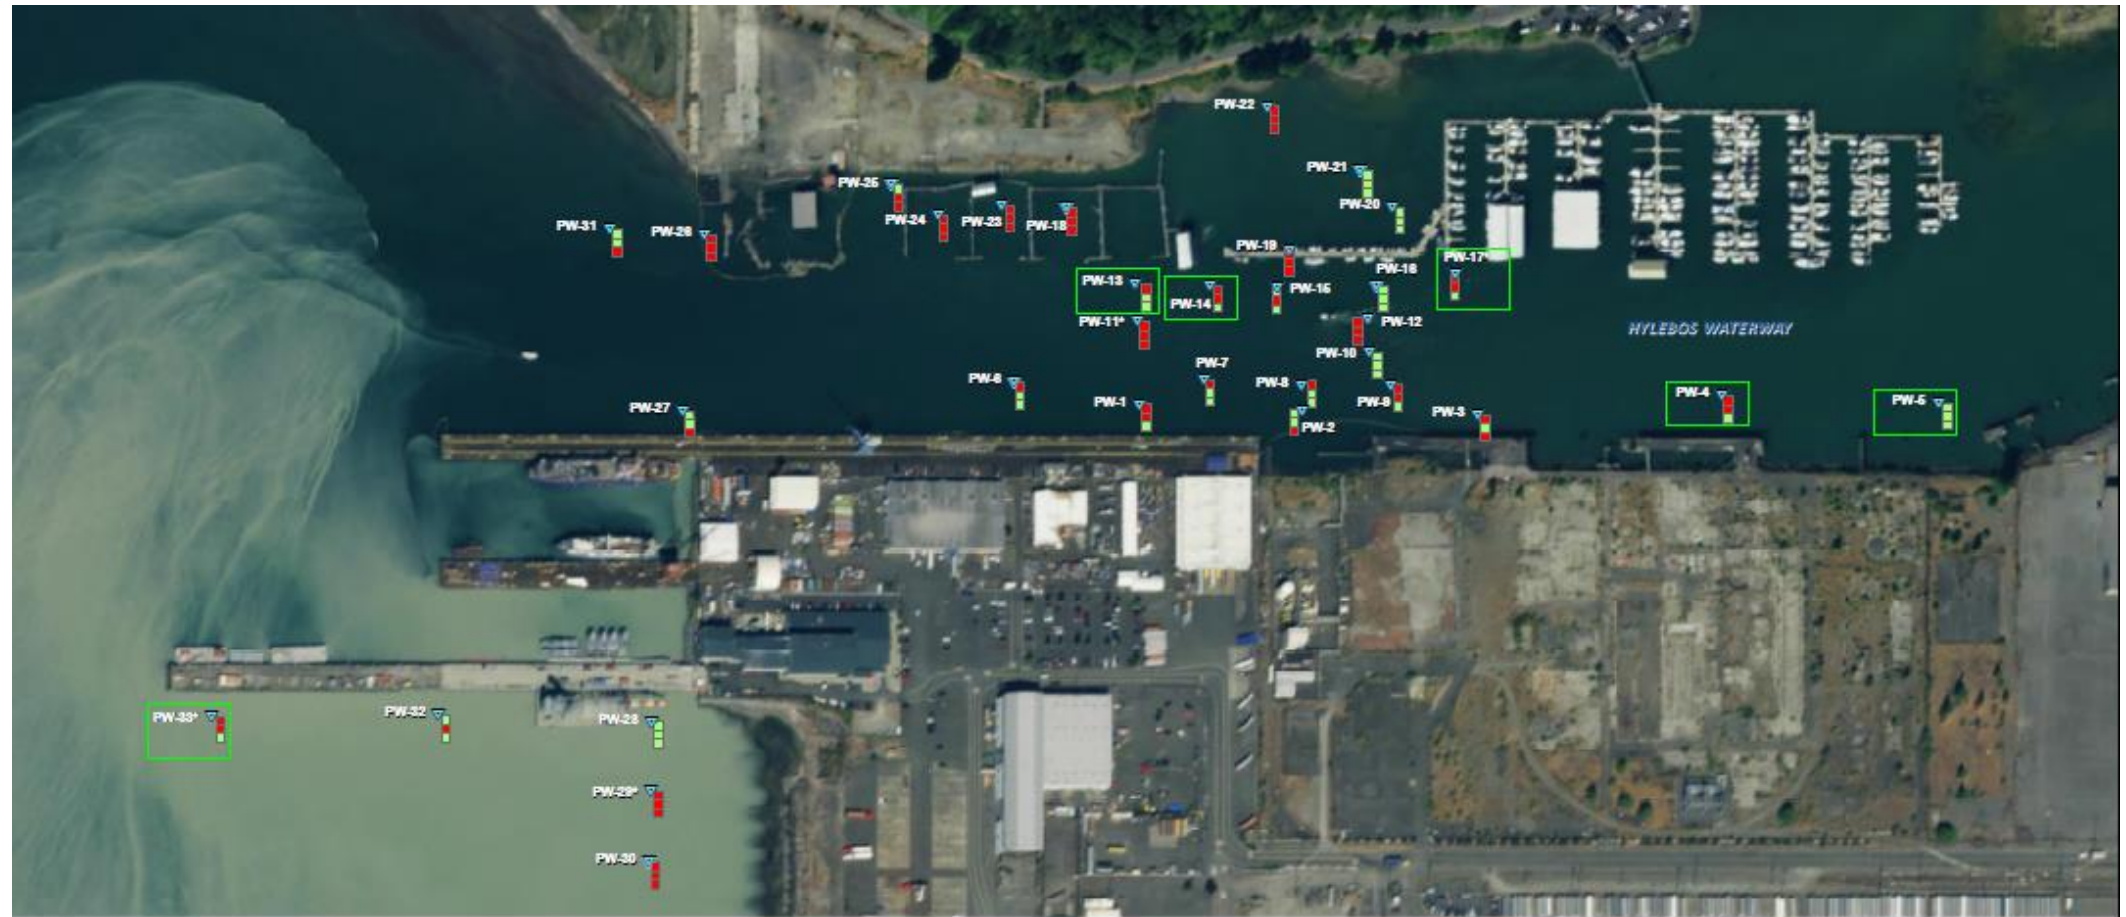
Sediment/Porewater Sampling 2016

All result intervals are non-detect for cVOCs with a MRL of 0.5 µg/L

Sample boxes represent the depth intervals where a sample was attempted. The top box represents the 10cm depth, then next box down represents the 30cm depth and the final box the 90cm depth.
