10 Years of Clean Water: Update on the Superfund Cleanup of the Thea Foss Waterway

City of Tacoma
Environmental Services Department

**IPS Briefing
June 14, 2017**

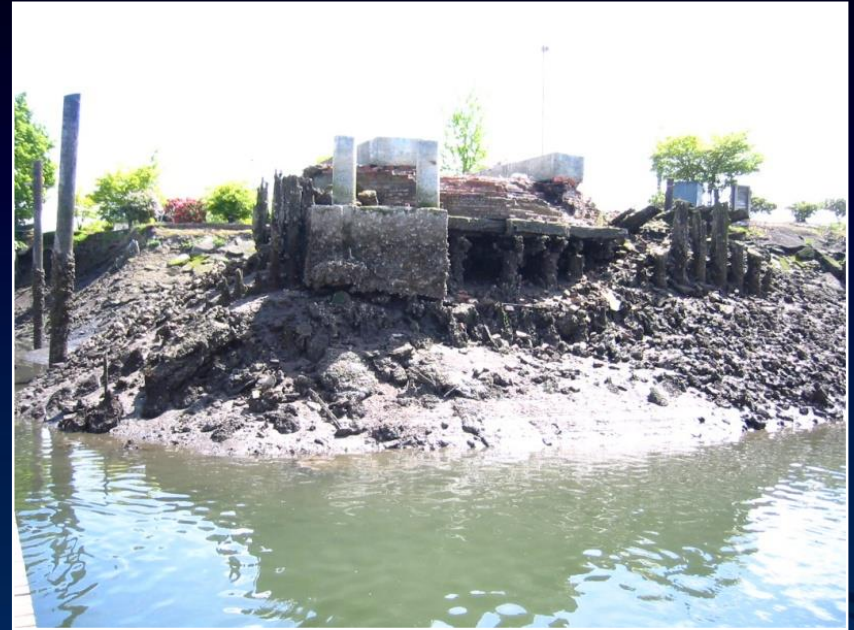
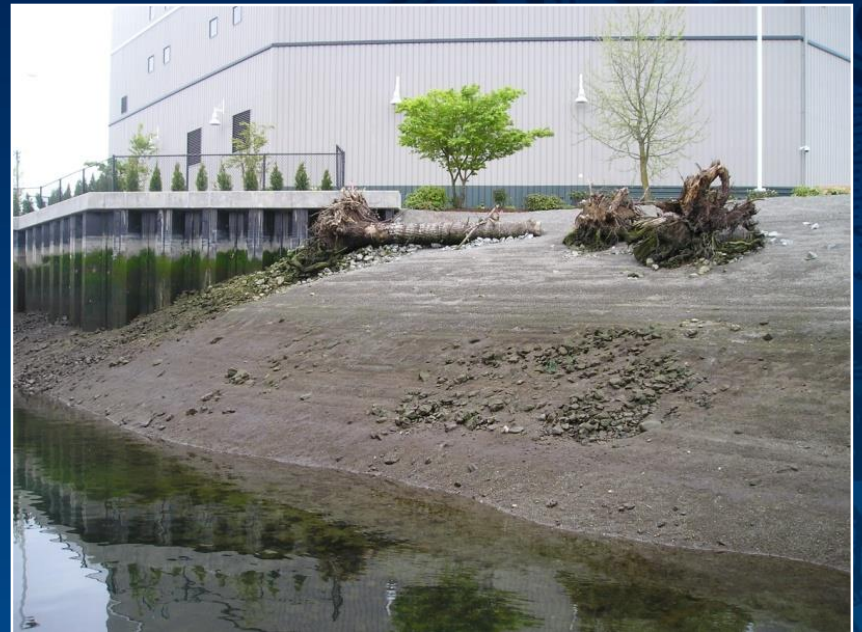
Cleanup Plan

- Combination of capping and dredging
- Dredged sediments were placed in the nearby St. Paul Waterway
- Habitat areas were constructed

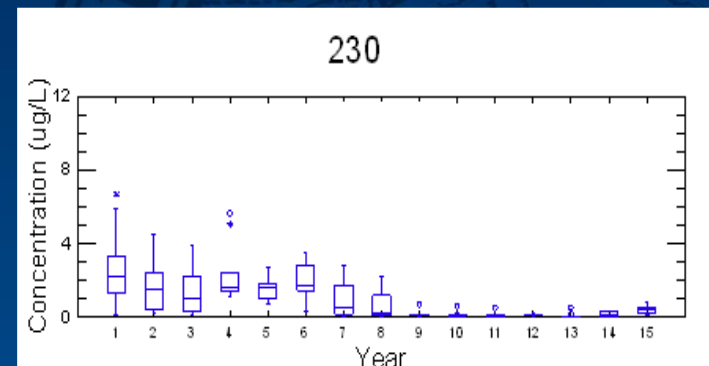
Example – Total HPAH concentrations have decreased to low levels and further reductions may not be feasible

Of the 49 tests performed, 47 have shown decreasing trends over the 15 year monitoring period

OUTFALL	CHEMICAL	PERCENT REDUCTION
In 5 Outfalls	Solids	54-72%
All 7 Outfalls	Lead or Zinc	45-79%
All 7 Outfalls	PAHs	86-98%
All 7 Outfalls	Phthalates	67-88%

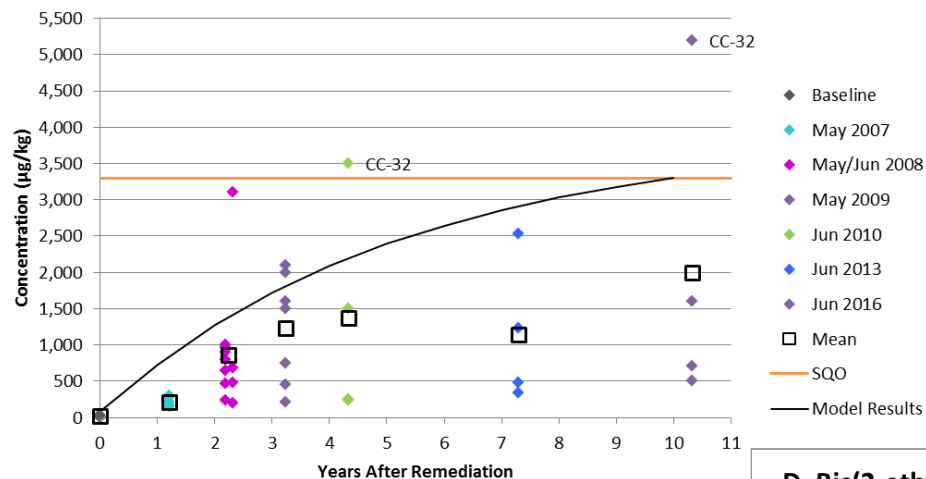
B. Pyrene

Predicted vs.
observed waterway
sediment
concentrations
